New York Racing Association, Civil Action No. CV-16-5442,

Aqueduct Racetrack - Quarterly Process Wastewater Report

In accordance with the above-referenced Consent Judgement and Decree (Decree), New York Racing Association, Inc. (NYRA) is pleased to present this Quarterly Process Wastewater Report covering the period between October 1 and December 31, 2016.

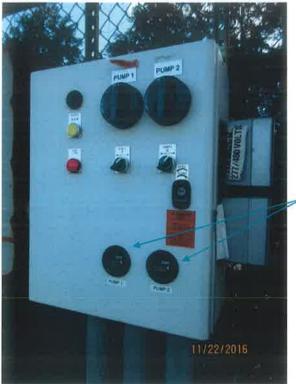
- Pump run-time meters were installed on October 12, 2016 as detailed in Section 3.2 of the WEP at the pump station located immediately prior to the municipal stormwater system connection near the intersection of 114th Street and North Conduit Avenue. A pump run-time log was maintained between October 21, 2016 and December 31, 2016, which is presented in Attachment B.

Photograph 1 – Pump run-time meters

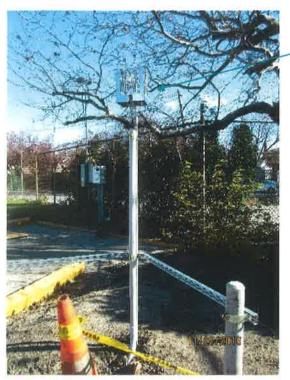
- » The southern solar-powered wet sensor malfunctioned as a result of moisture building up in the housing of the electronic component. This occurred twice during this reporting period and the sensor was replaced. The sensor was not operational October 25th to 26th and November 30th to December 5th. NYRA and Monnit personnel are currently working together to identify how this malfunction can be prevented in the future. A system more compatible with the northeast climate may need to be purchased.

Photograph 2 – Solar powered wet sensor electronic housing

- NYRA has requested that Monnit further evaluate the wet sensor housings to evaluate how moisture can be prevented from entering the main electronic housing, which causes the system to malfunction. In addition, NYRA will equip the wet sensor housings with a secondary plexi-glass cover to limit the potential for moisture to enter the housings.
- NYRA is currently continuing to work on repairing stormwater gutter systems associated with the barns.
- NYRA has contracted with a NYSDEC-permitted hauler to vacuum out the wash bay oil/water separator, located in the equipment building, on a monthly basis. Residual waste will be disposed at a NYSDEC-permitted facility.
- The wash bay is being upgraded with partitions to control over-spray within the garage

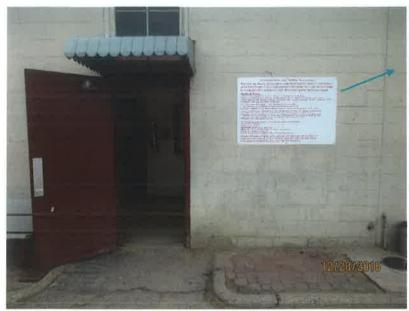
» This area was compliant with the WEP with the exception of a missing wastewater management sign inside near the employee breakroom, which was corrected.

Photograph 3 - Equipment Building employee entrance

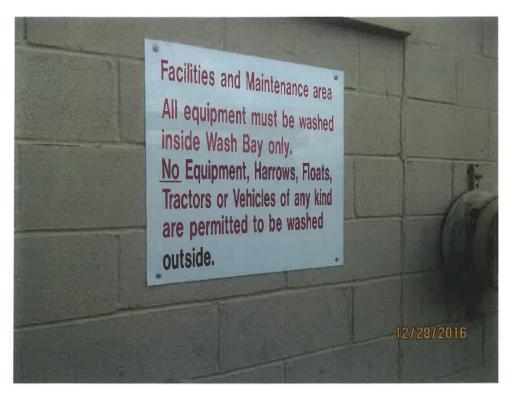
Photograph 4 – Equipment Building sign posting near garage bays north and south sides.

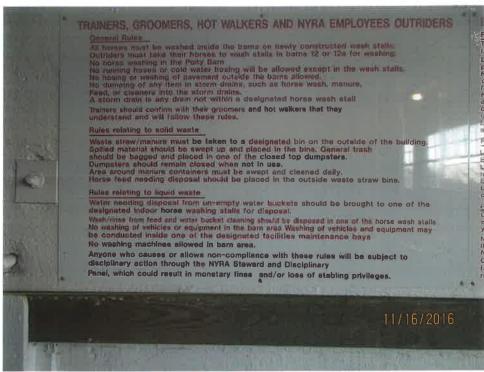
- Signs detailing wastewater management requirements were posted at the barns and equipment buildings. A photograph of the signs posted are presented in **Attachment A**.

Photograph 5. Wastewater management notification sign posted in the barn area

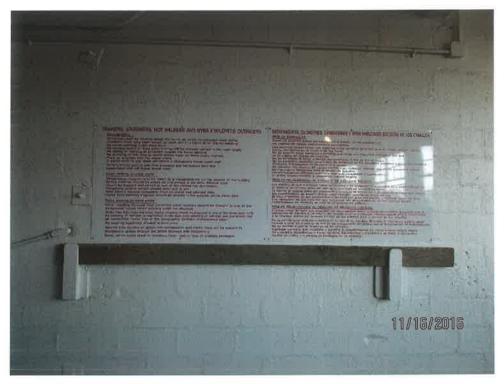
Photograph 6. English and spanish postings
