RE: New York Racing Association, Civil Action No. CV-16-5442,  
Aqueduct Racetrack – Quarterly Process Wastewater Report

In accordance with the above-referenced Consent Judgement and Decree (Decree), New York Racing Association, Inc. (NYRA) is pleased to present this Quarterly Process Wastewater Report covering the period between April 1 and June 30, 2017.

**Project Photographs**

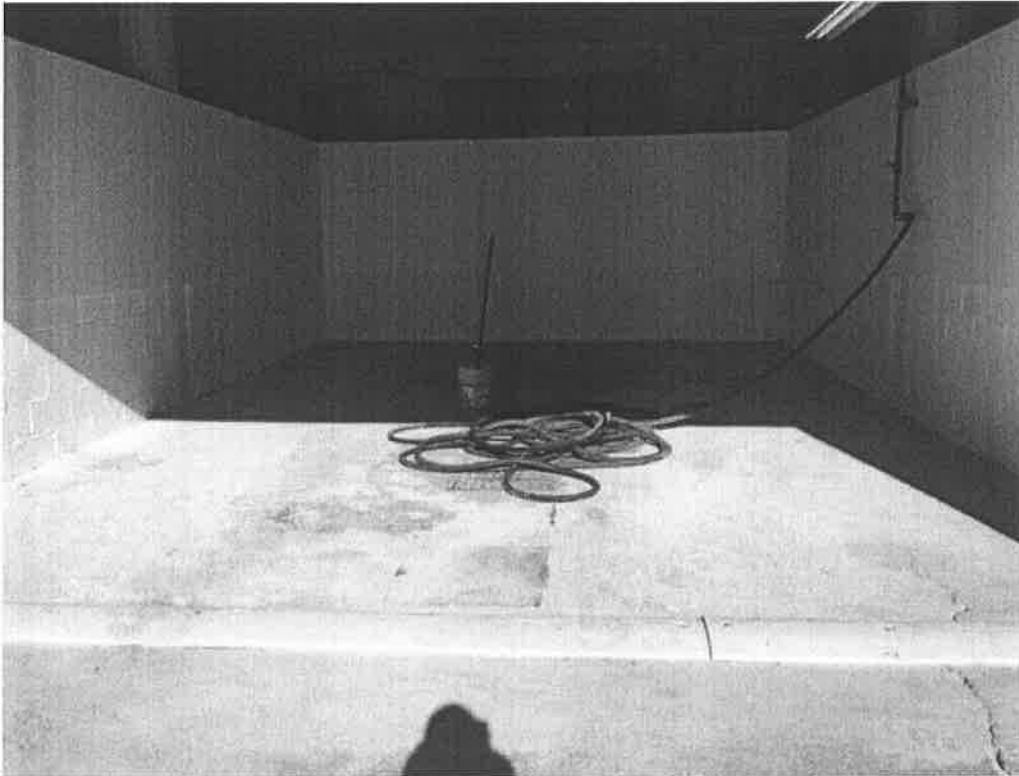
Photograph 3 – New equipment wash bay.
